Memorandum / Filenote

Watercourse / Drainage Feature Determination Supporting Information

To	Waratah Coal
From	Orange Environmental
CC	
Date	20-Dec-2019
Ref	WC-GCP-MM002, Rev 0
Subject	Galilee Power Station

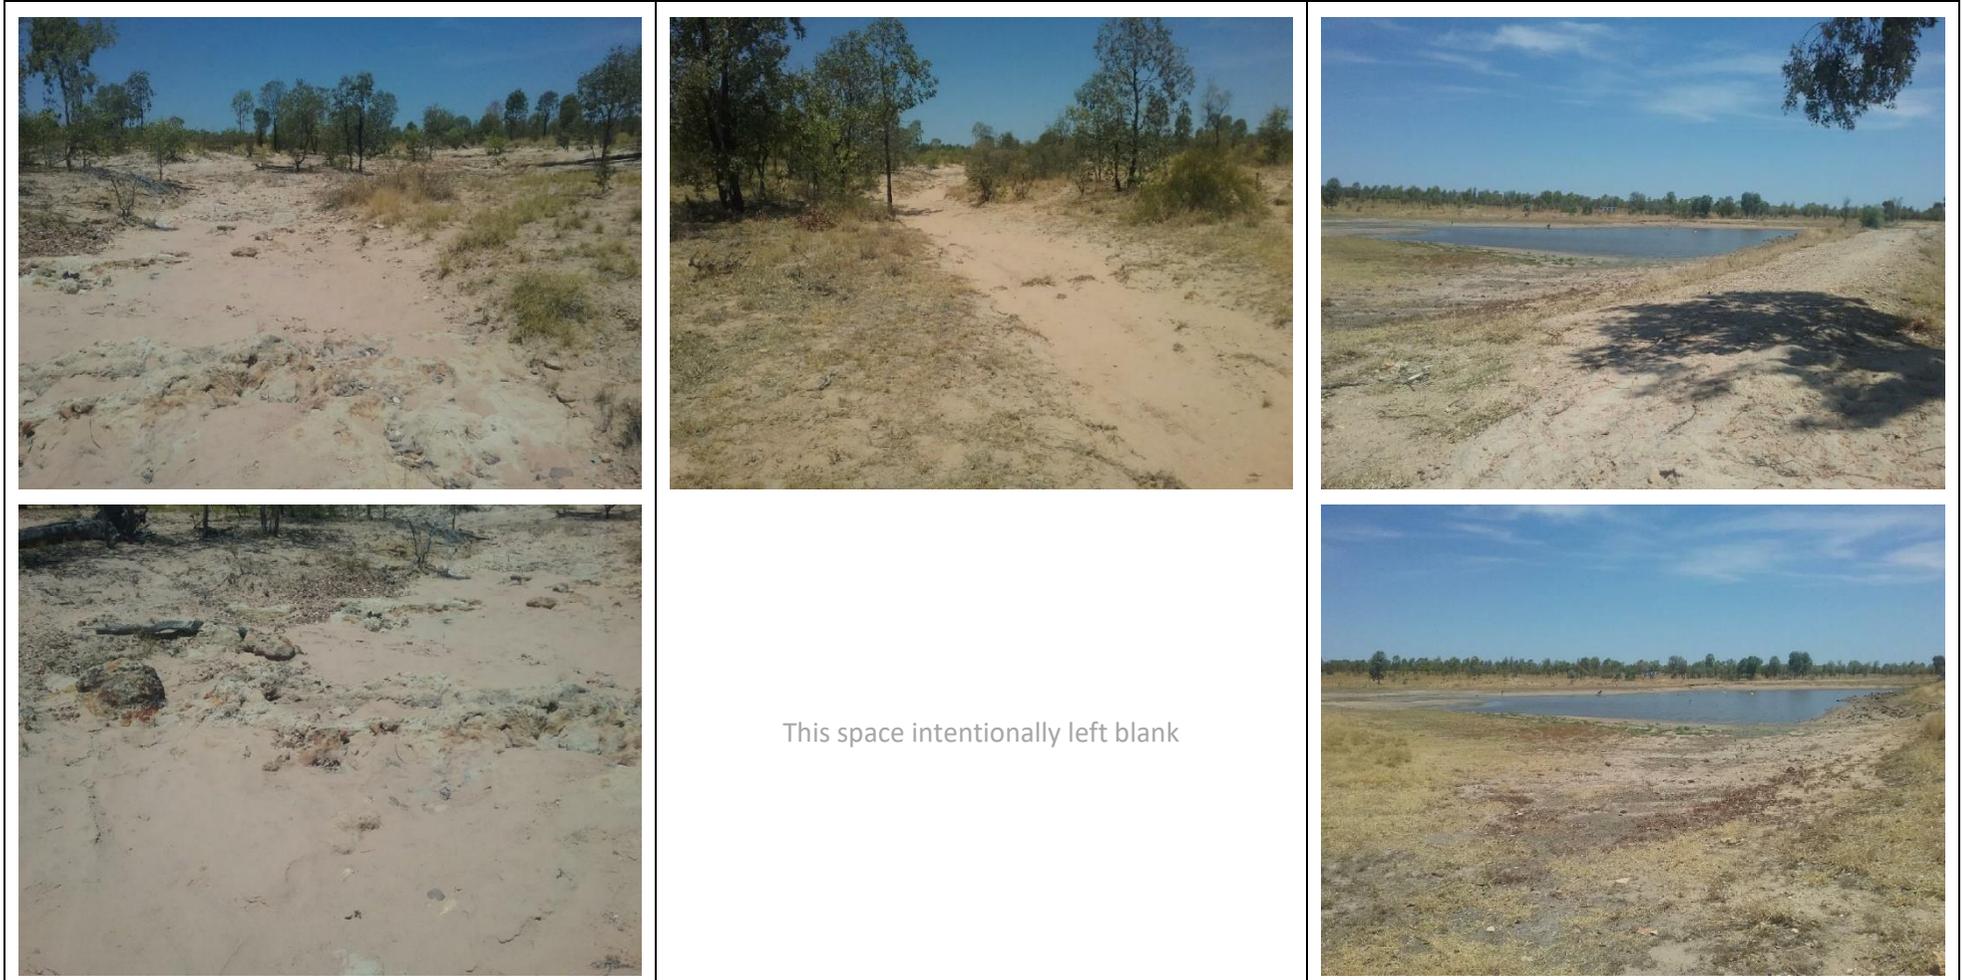
Location 9 – Channel at easternmost point investigated [2 photos]

Location 8 – Channel of fine sand, 10 m wide, 1m deep [1 photo]

Location 6 – Mapped impoundment [2 photos]

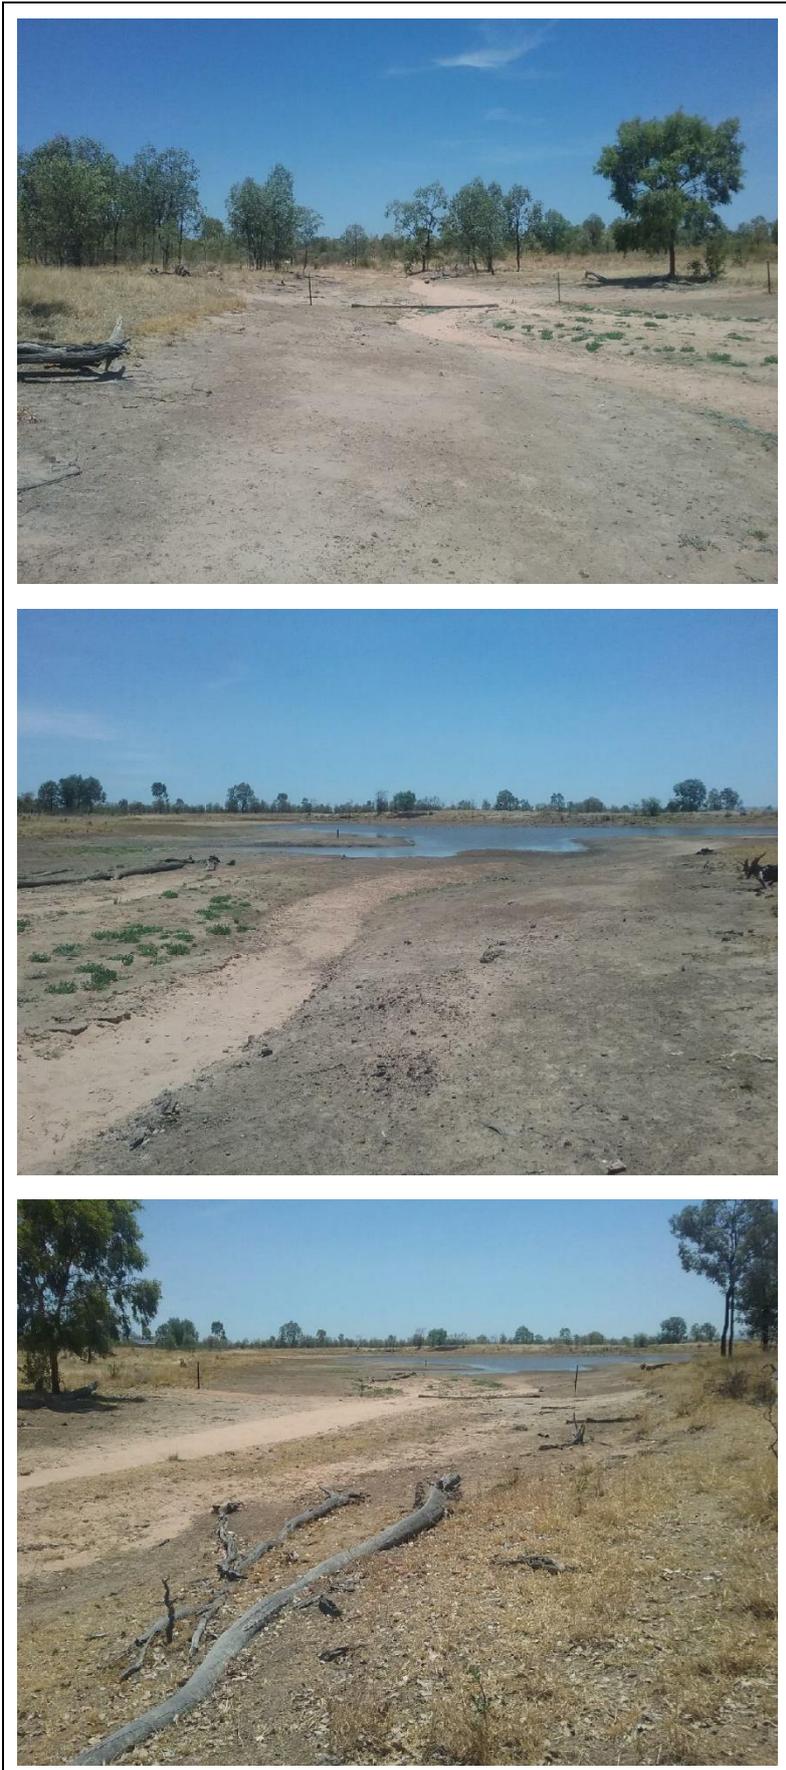
Location 7 – Mapped impoundment [3 photos]

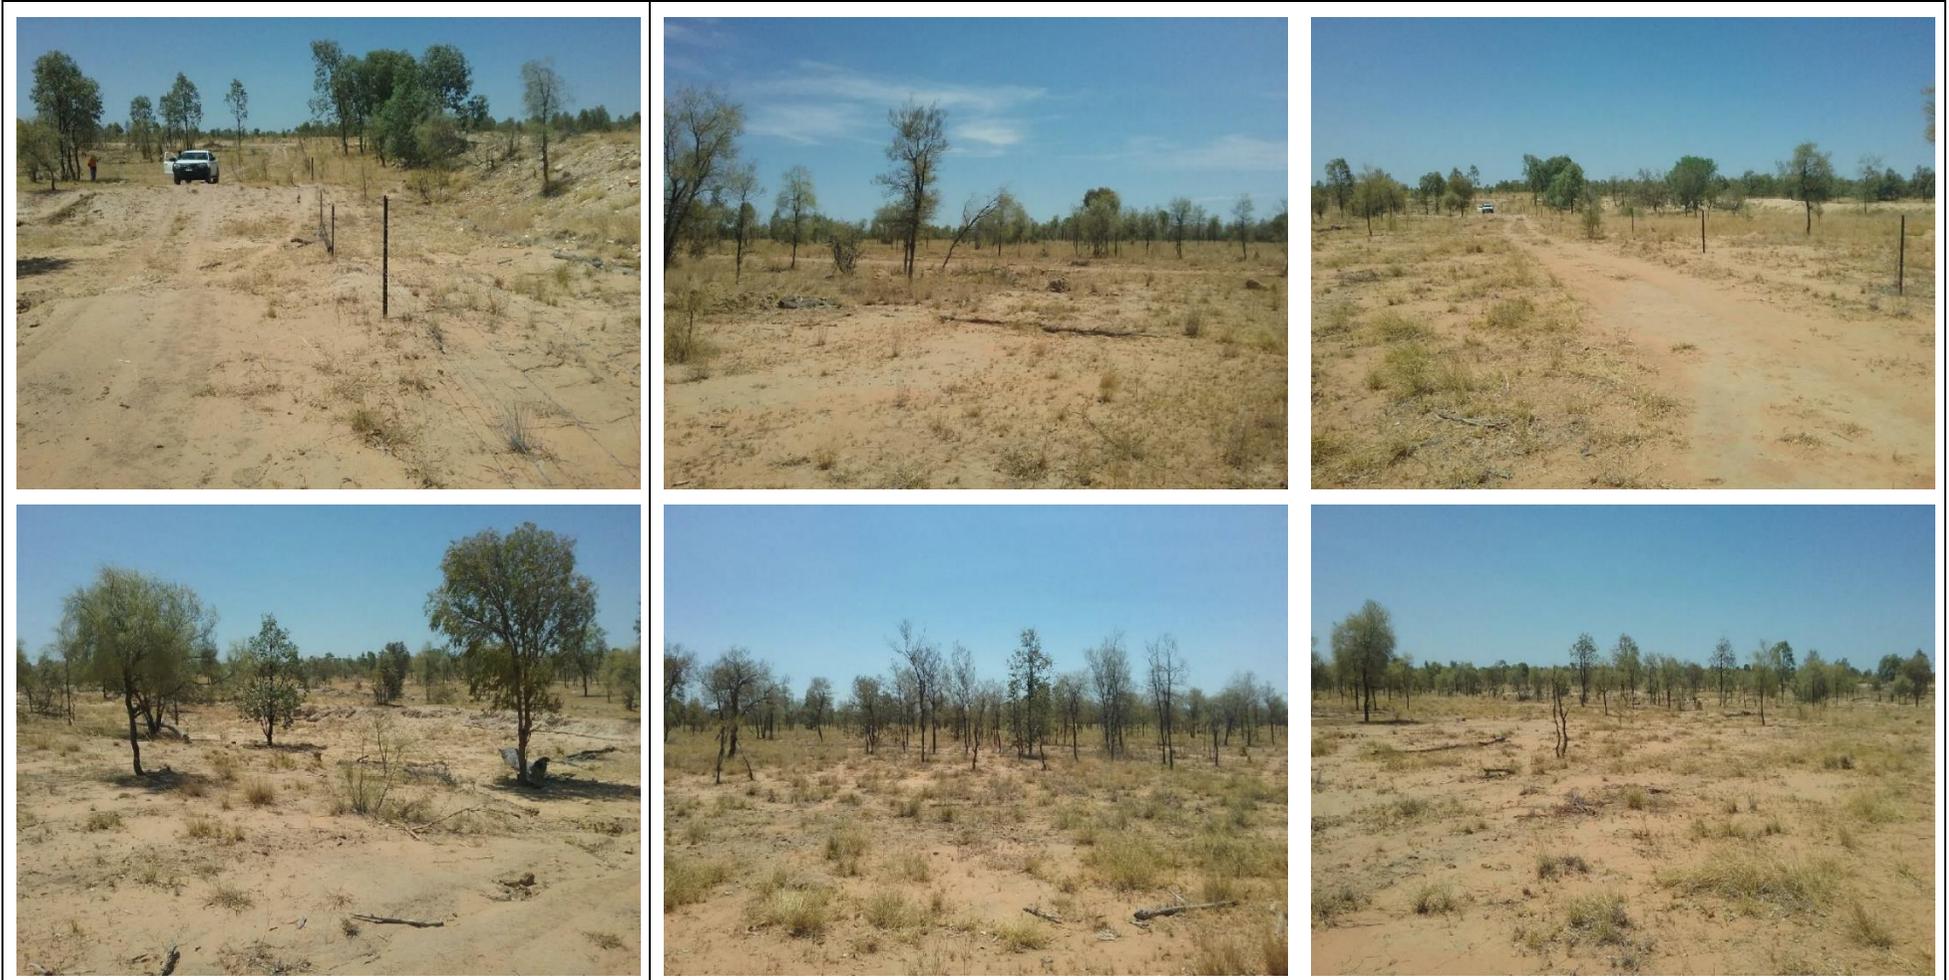
Location 11 (2 photos)

Location 10 (4 photos)

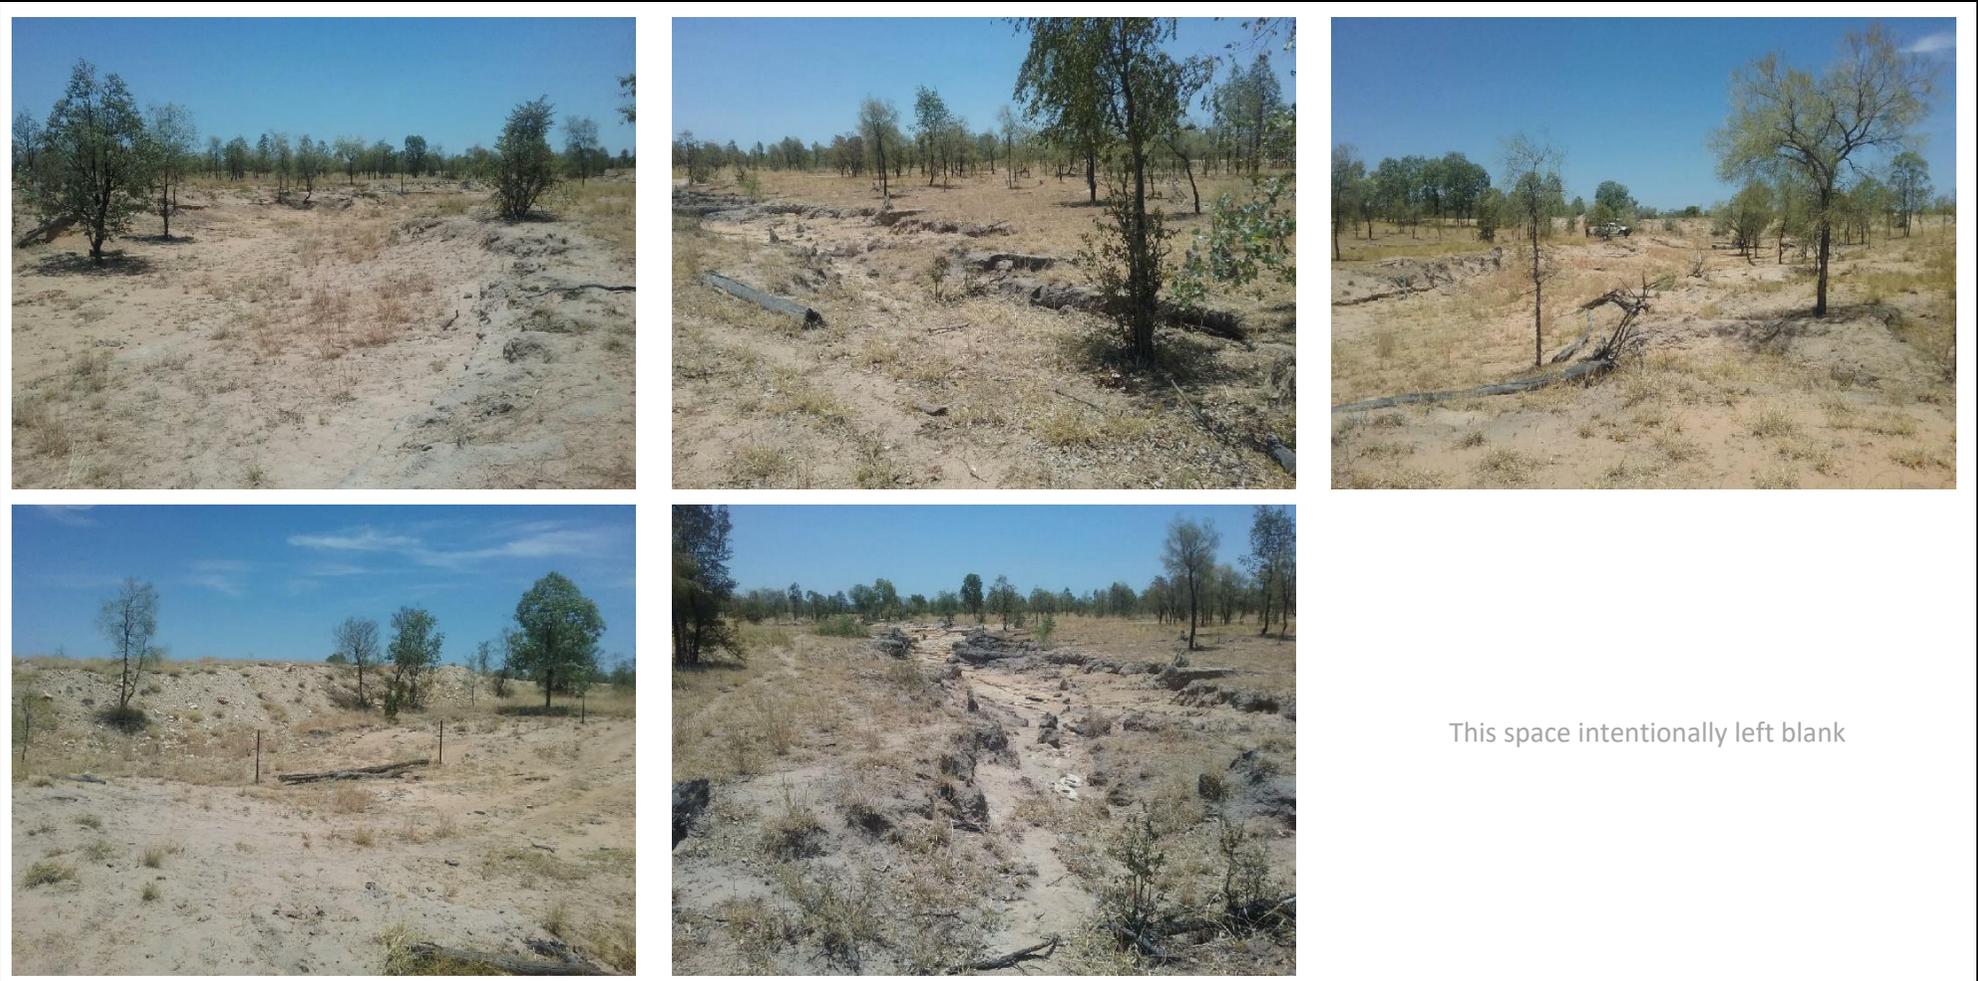
Location 1 - Obvious channel but no high bank, 15 m low bank to low bank near dam wall, to 7m at 50m downstream of dam wall. No riparian vegetation (5 photos)

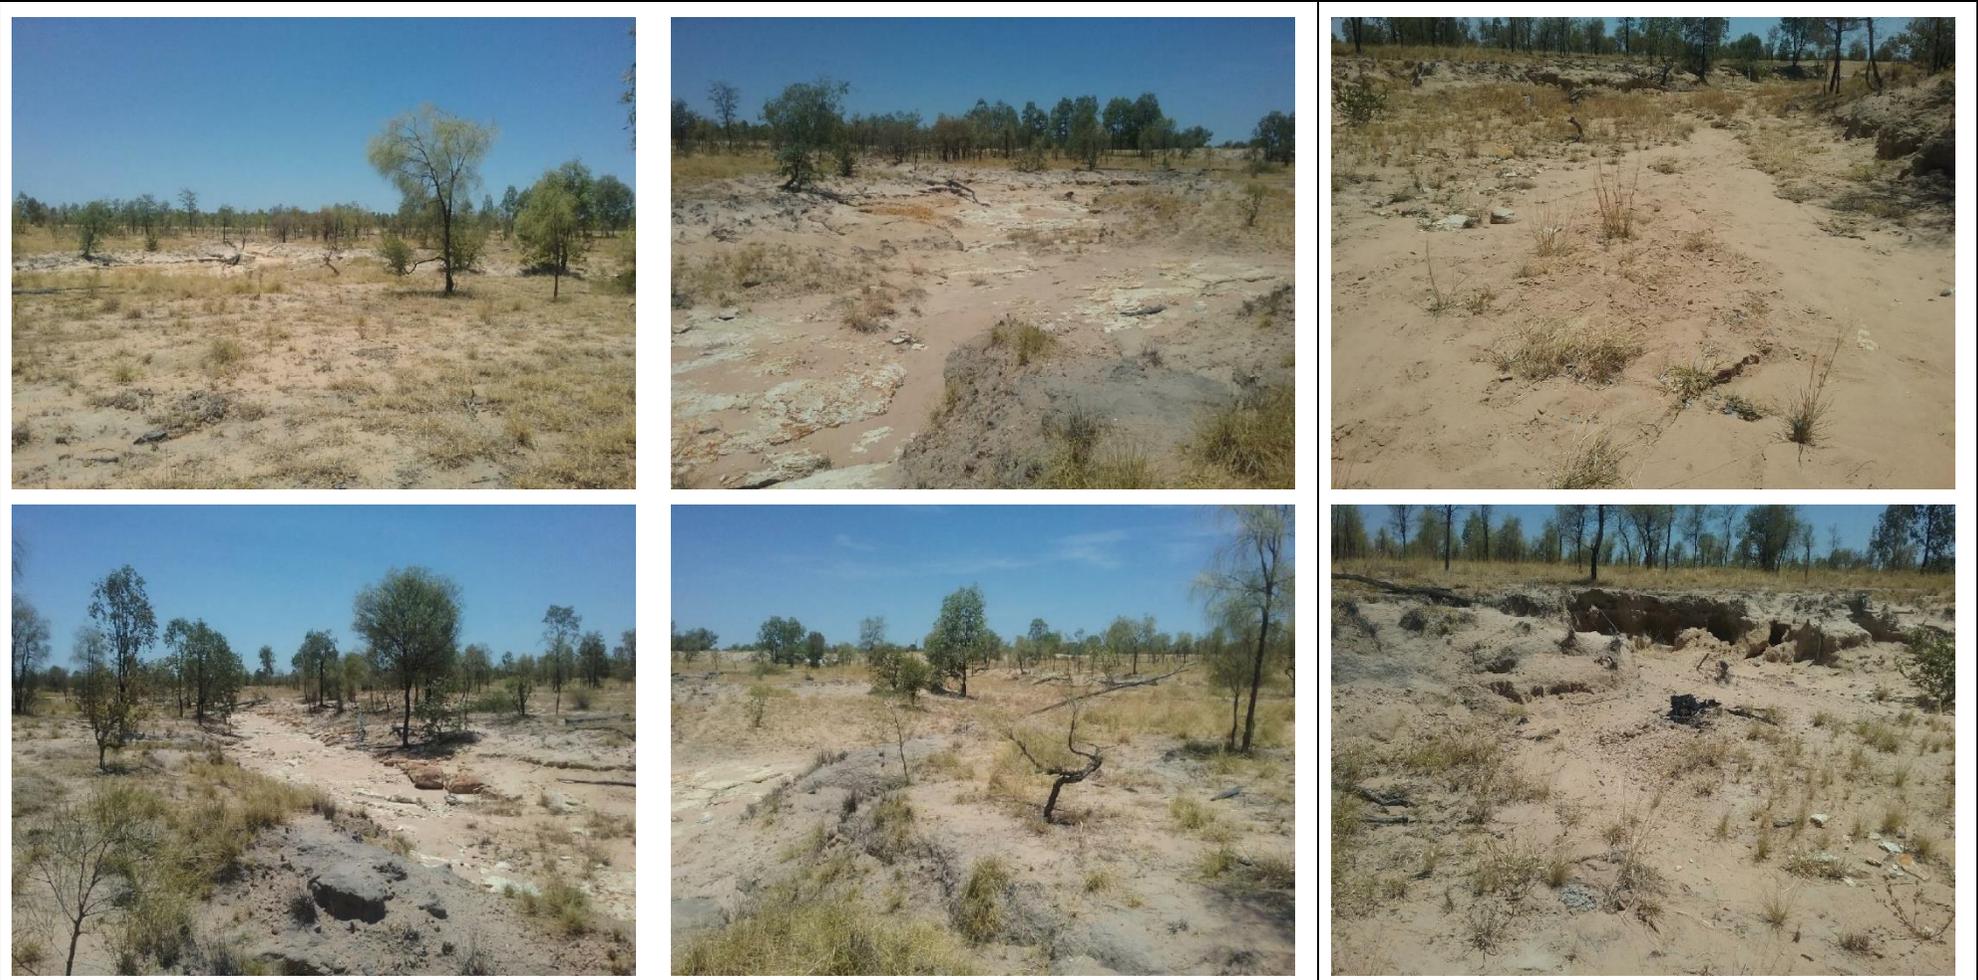
Location 2 - Non remnant regrowth, tall shrubland, *Acacia oswaldii* to 4m with *E. melanophloia*, *Corymbia sp* [clarksoniana?], *C. dallachiana*, *P. pubescens*; ground layer containing buffel grass with *E. mucronata*, *T. pungens*, *H. contortus*. Alluvial gently undulating plains over shallow sandstone [4 photos]

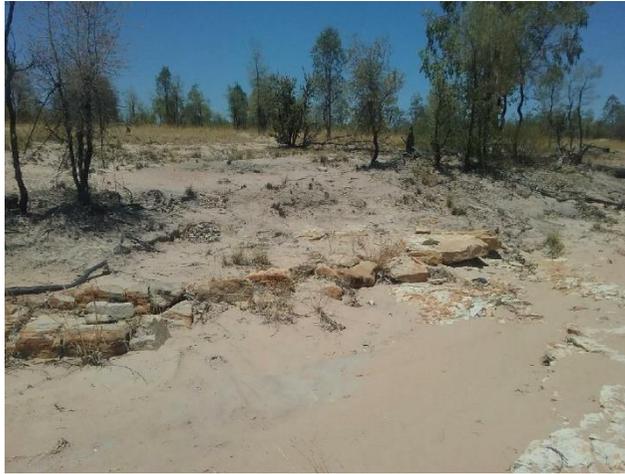
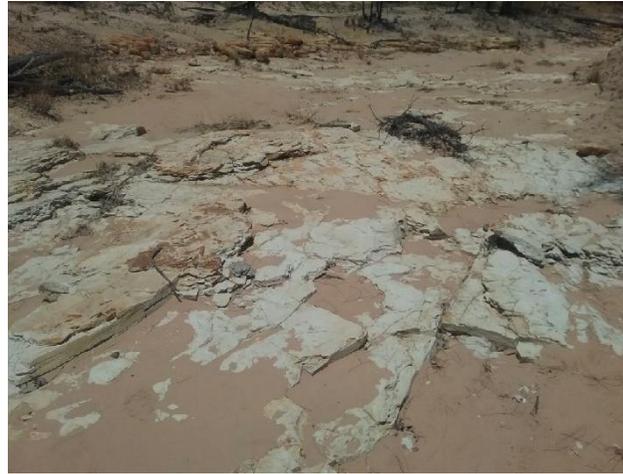
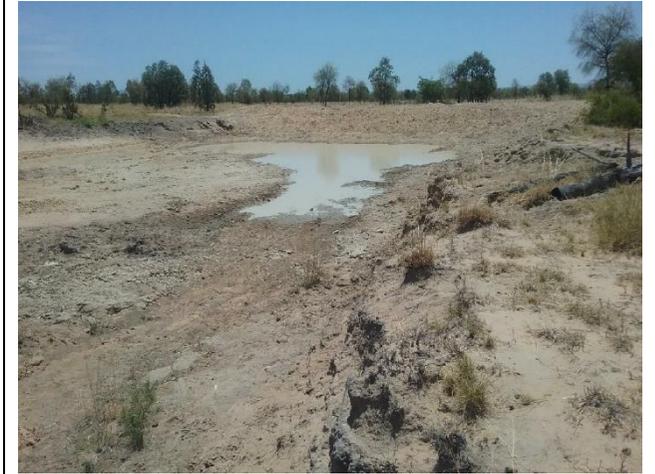
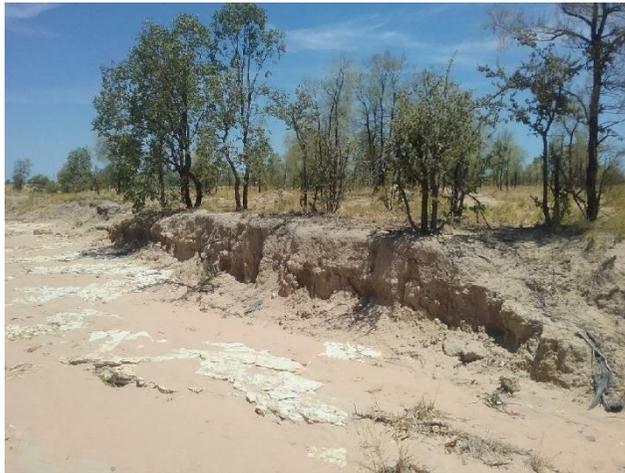
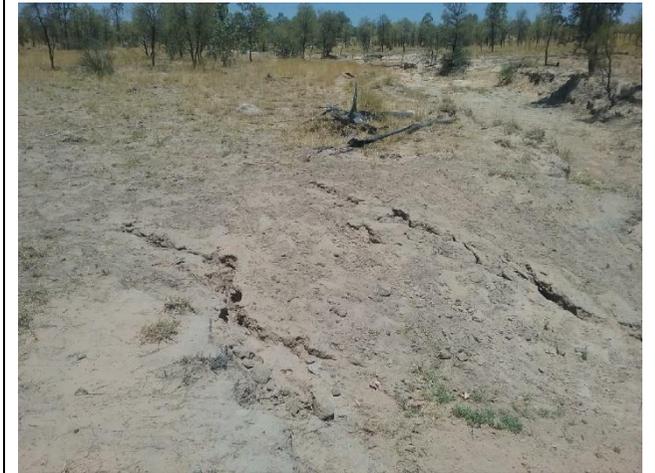
Location 4 - Channel bank incised 1-1.2m deep, dry, minor riffles and in-stream channelling [2 photos]

Location 3 - Channel of fine sand over sandstone and siltstone sheets (3 photos)

Location 5 - New dam wall placed across drainage line (2 photos)

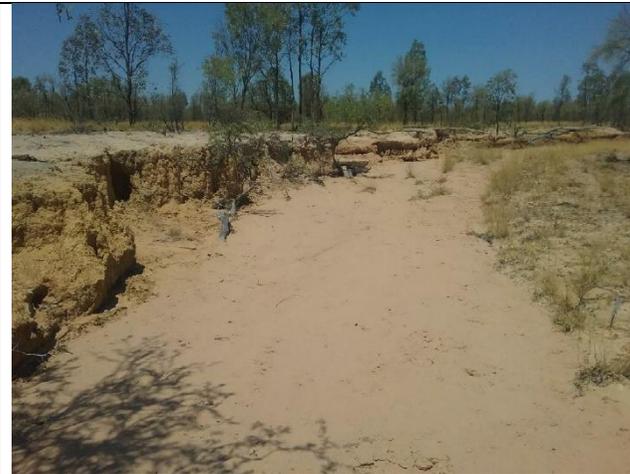
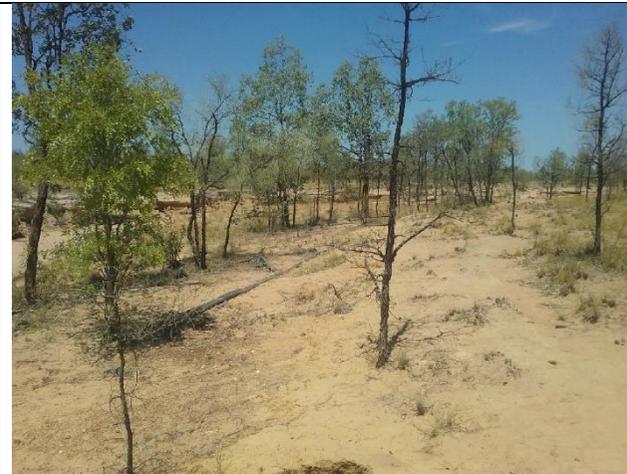
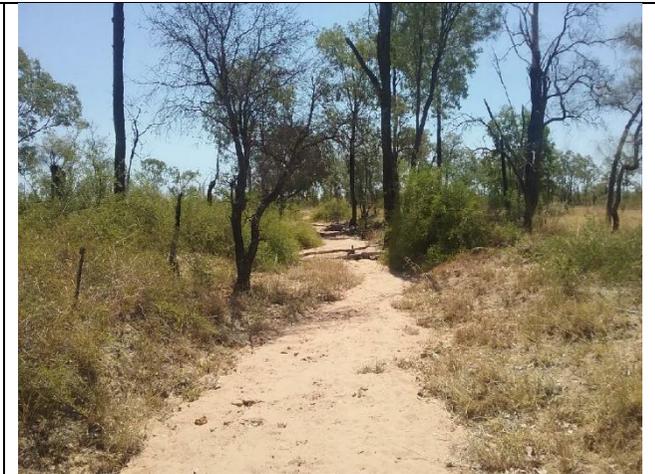
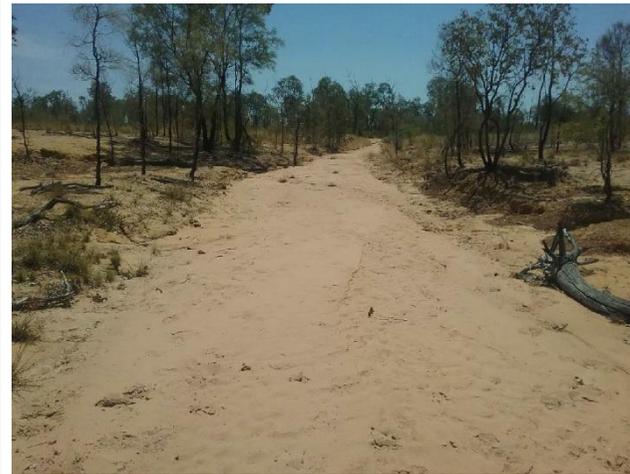
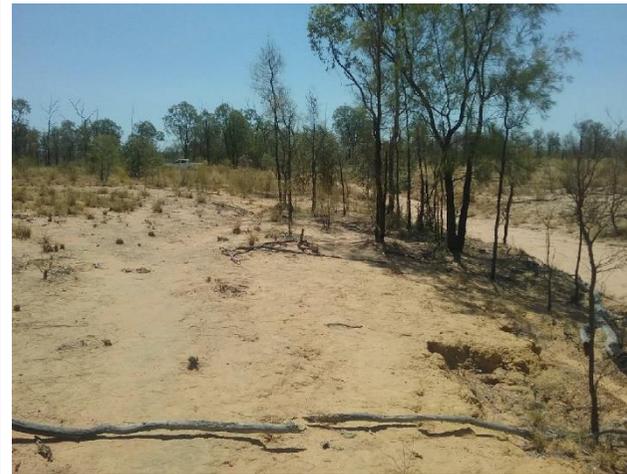
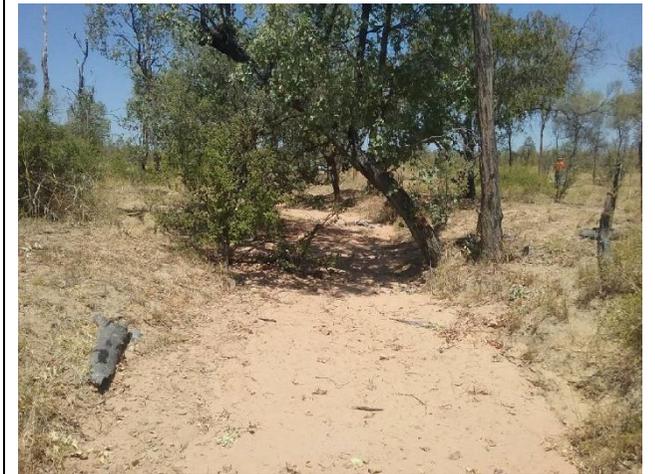
Location 12 - Channel drains low rise onto plain at this point, incised 1.7 m at 20m upstream to 40cm at 30m downstream, bed of loose sand, some minor riffles and shallow in-bed channelling, no high bank, no riparian vegetation [2 photos]

Location 13 - *E. melanophloia*, *G. pteridifolia*, *Acacia subterete* [2 photos]

Location 14 - Sandy channel, 2-3m wide, 70cm deep [2 photos]

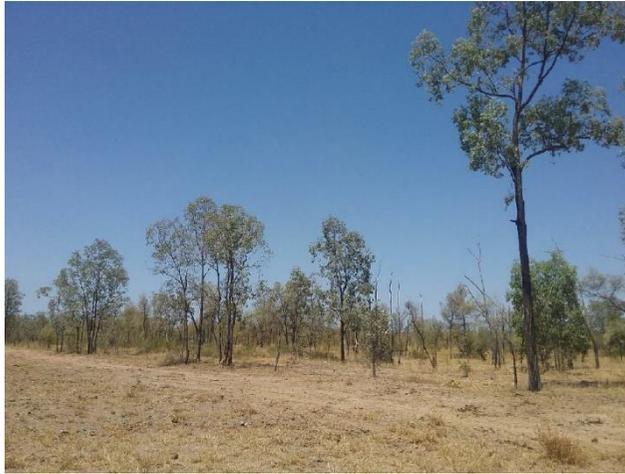
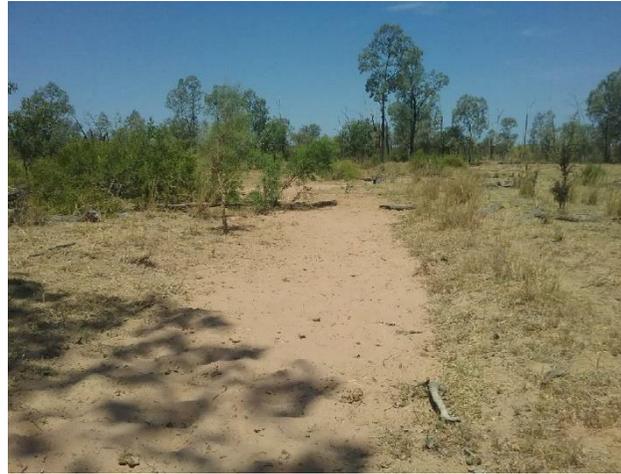
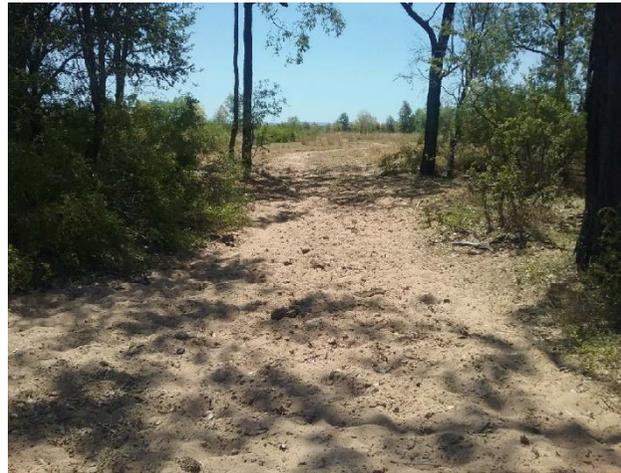
Location 15 - *E. melanophloia*, open woodland sandy alluvium gently undulating to level plains [1 photo]

Location 16 - Channel 3-5m wide 20-50 cm deep, sandy [2 photos]

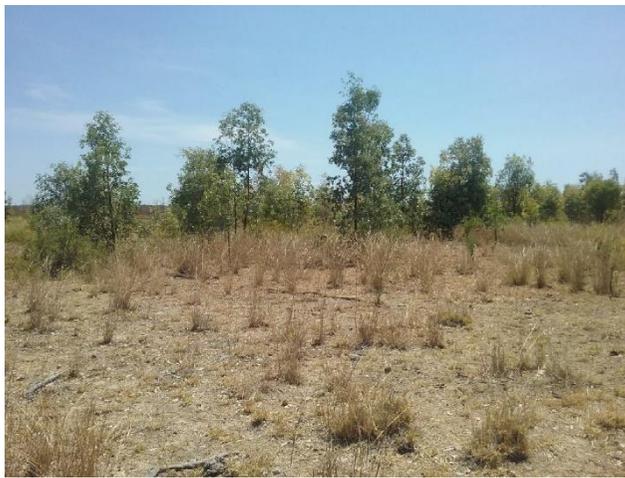
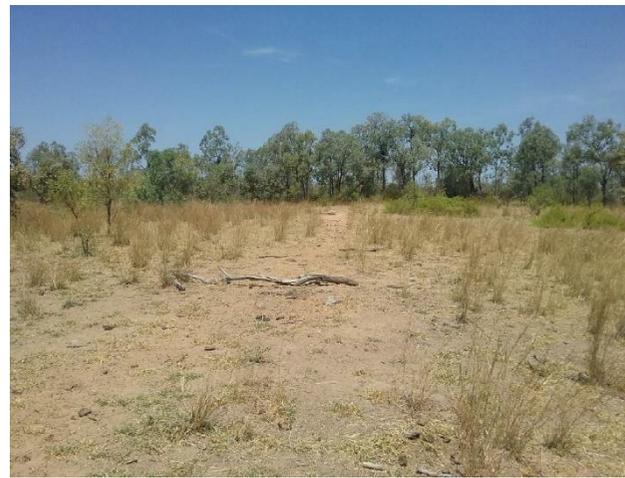
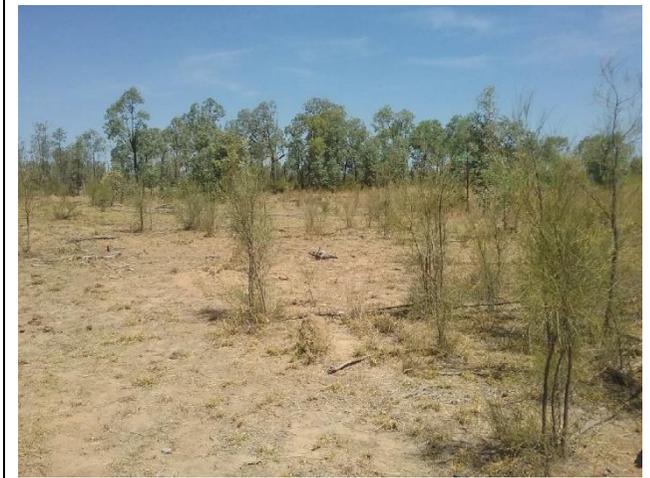
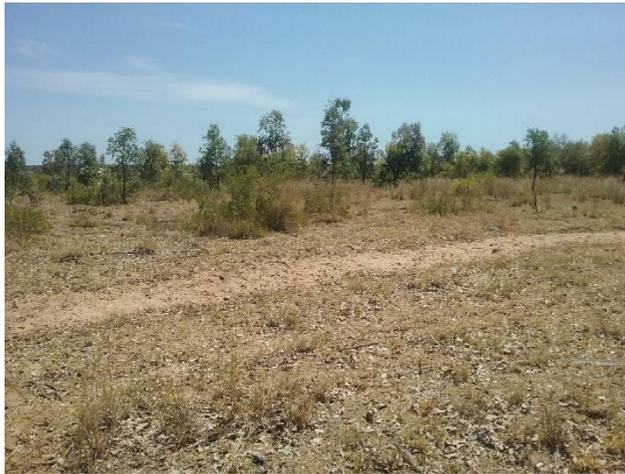
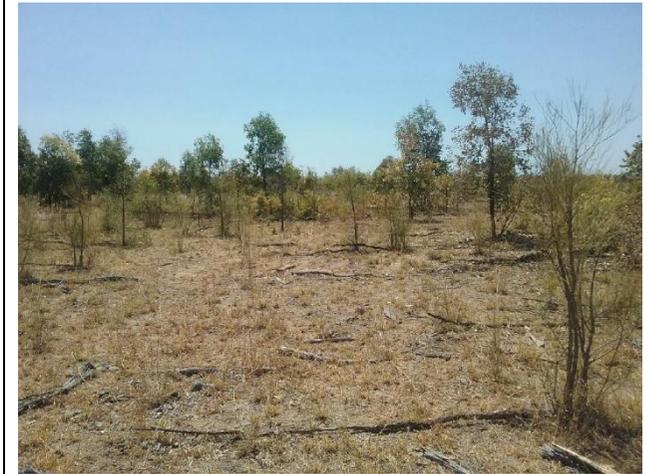
Location 18 - Channel loses definition at this point, flows SW, no longer has defined banks or bed (2 photos)

Location 19 - Low mid-delta bank, not a bed (1 photo)

Location 20 - Approximate edge of delta (2 photos)

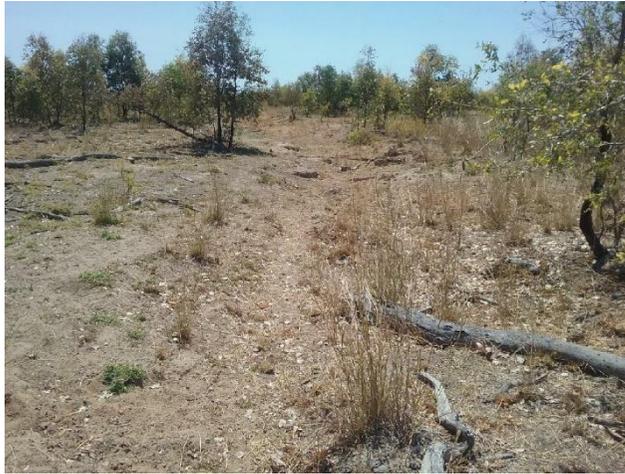
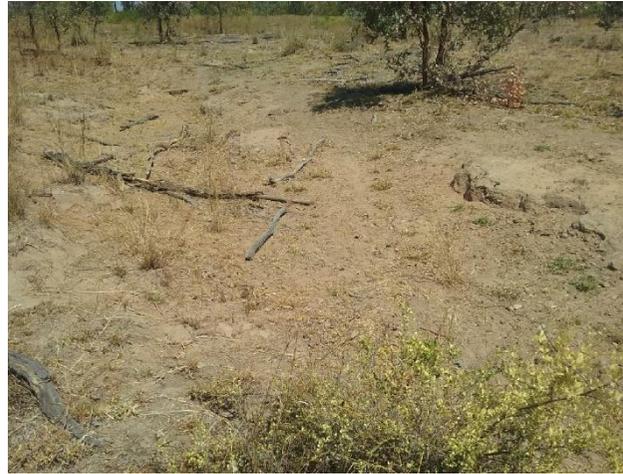
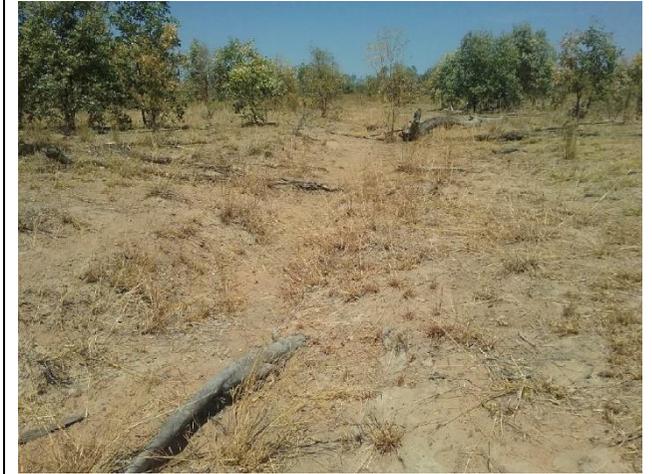
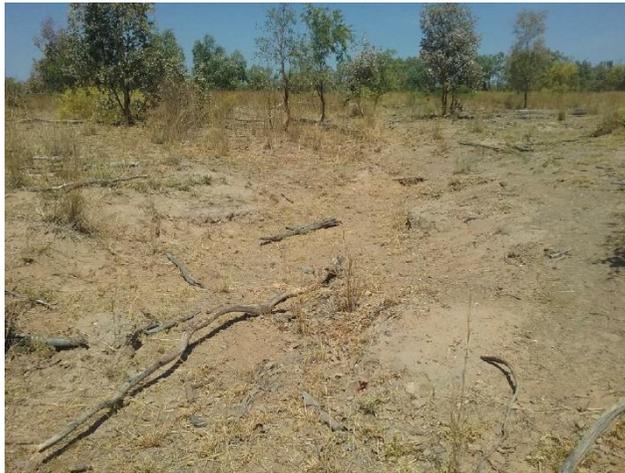
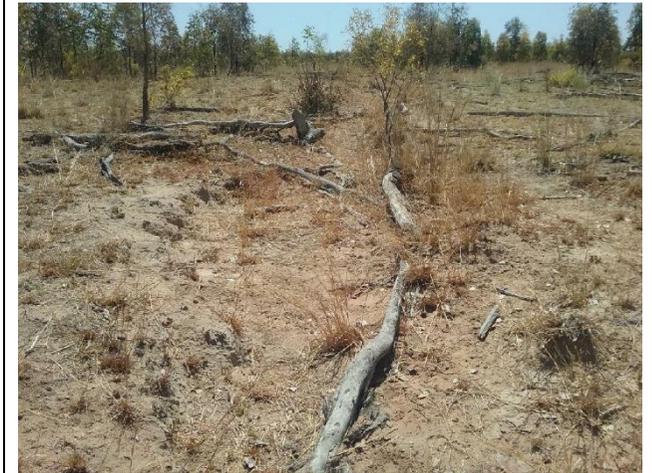
Location 21 - Channel restarts in clay loam, 20-40 cm deep to 2-3m wide [3 photos]

Location 22 - *E. melanophloia*, low open woodland non remnant, no riparian vegetation [2 photos]

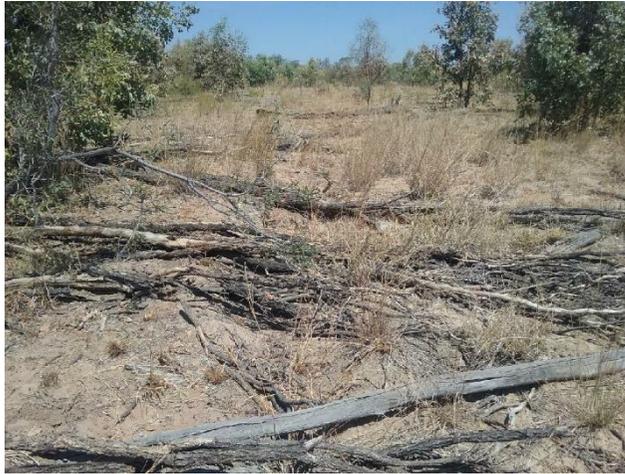
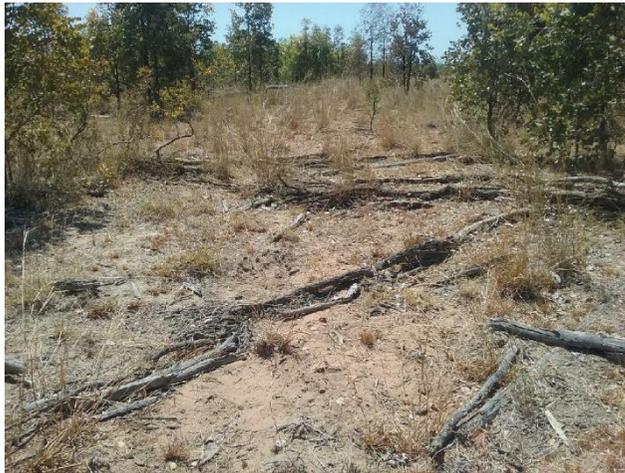
Location 23 - Channel 30cm deep >1m wide (2 photos)

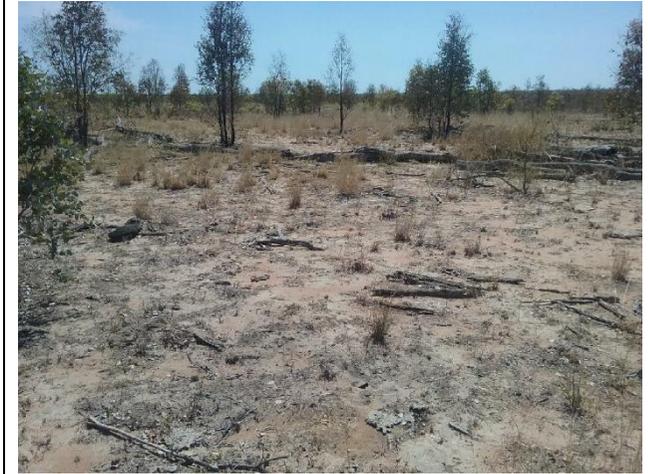
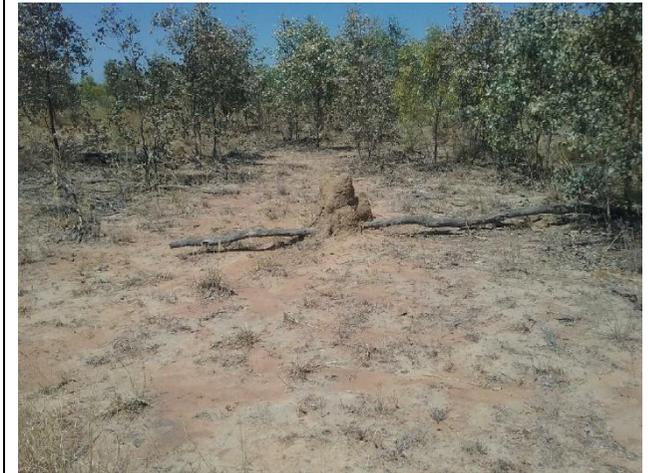
Location 25 - Channel is a shallow pan / open depression with no bank (2 photos)

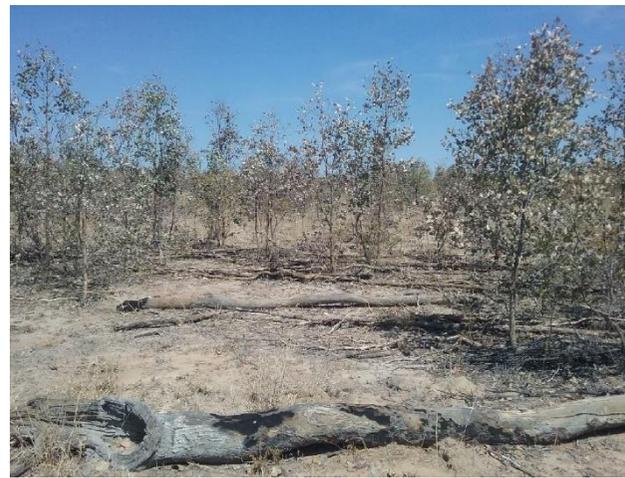
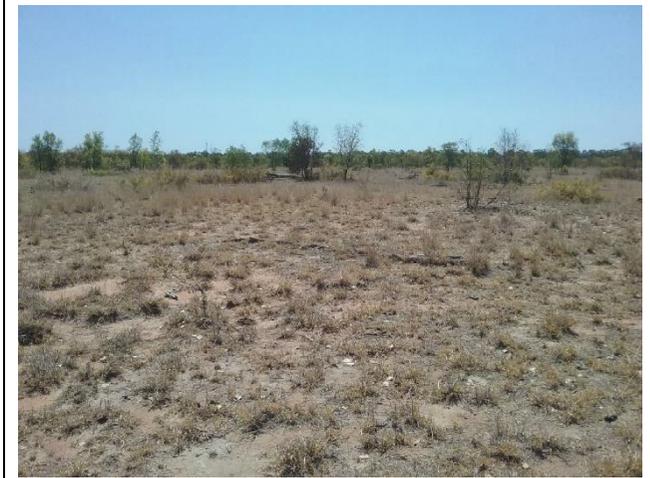
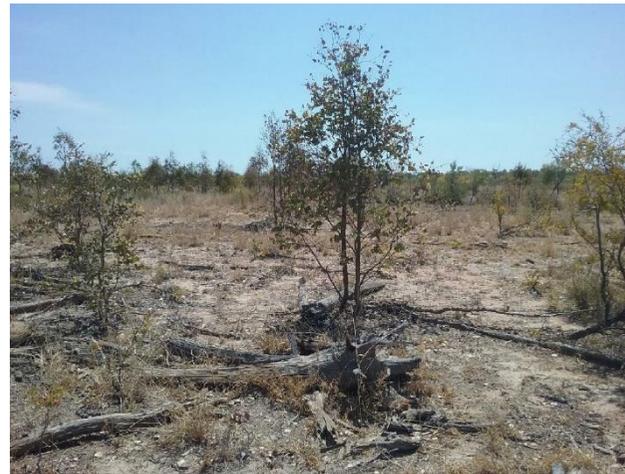
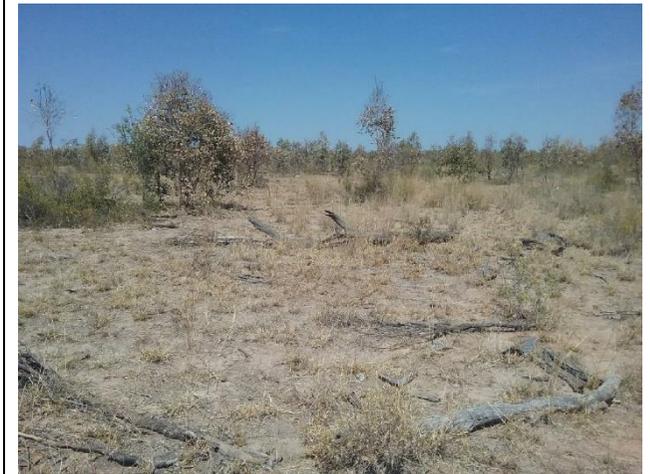
Location 27 - *E. melanophloia* regrowth [2 photos]

Location 28 - Edge with *E. melanophloia* regrowth [2 photos]

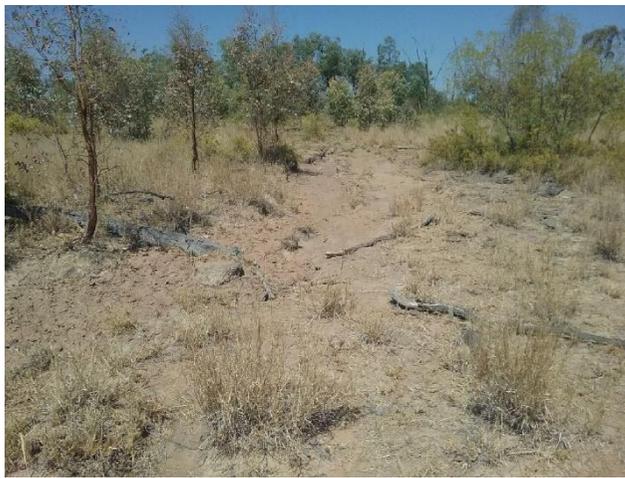
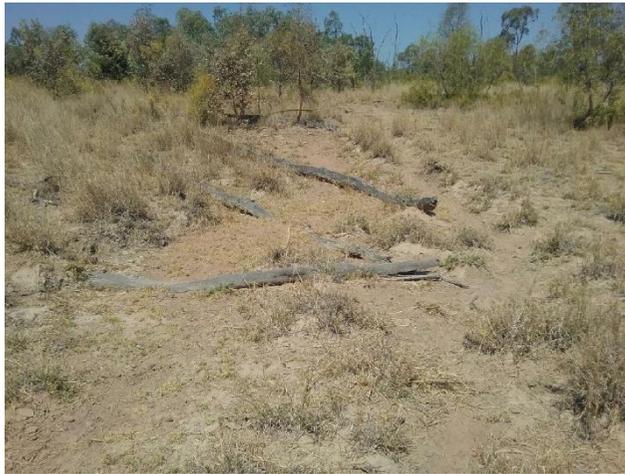
Location 29 - Shallow gully erosion (2 photos)

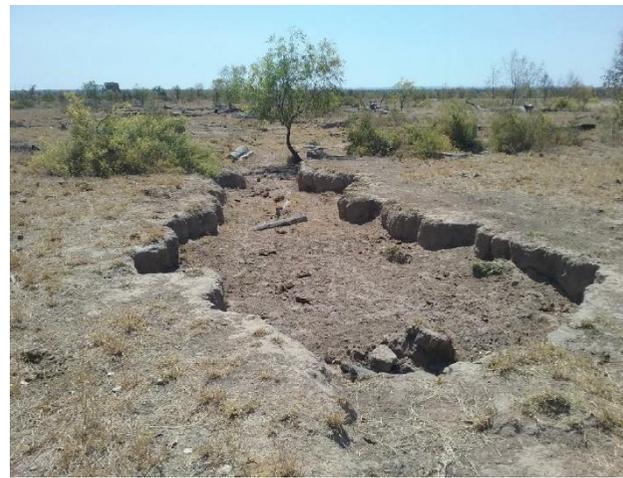
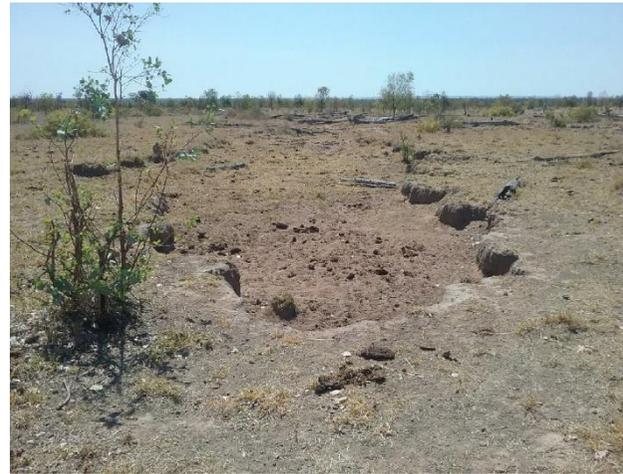
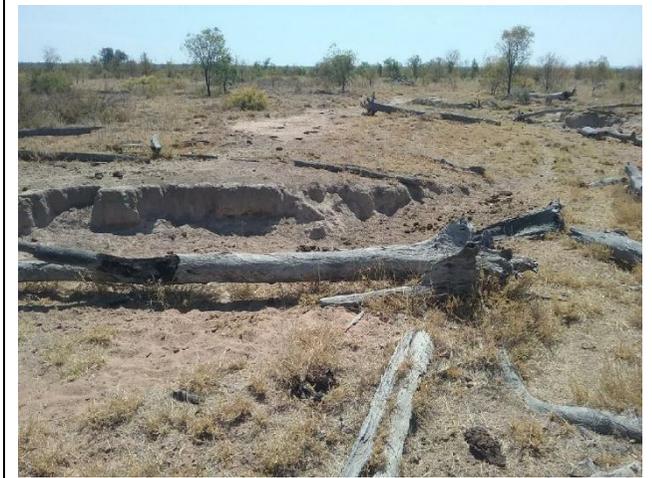
Location 30 - Gully erosion 50 cm deep, 1 - 3 m wide (2 photos)

Location 31 (1 photo)

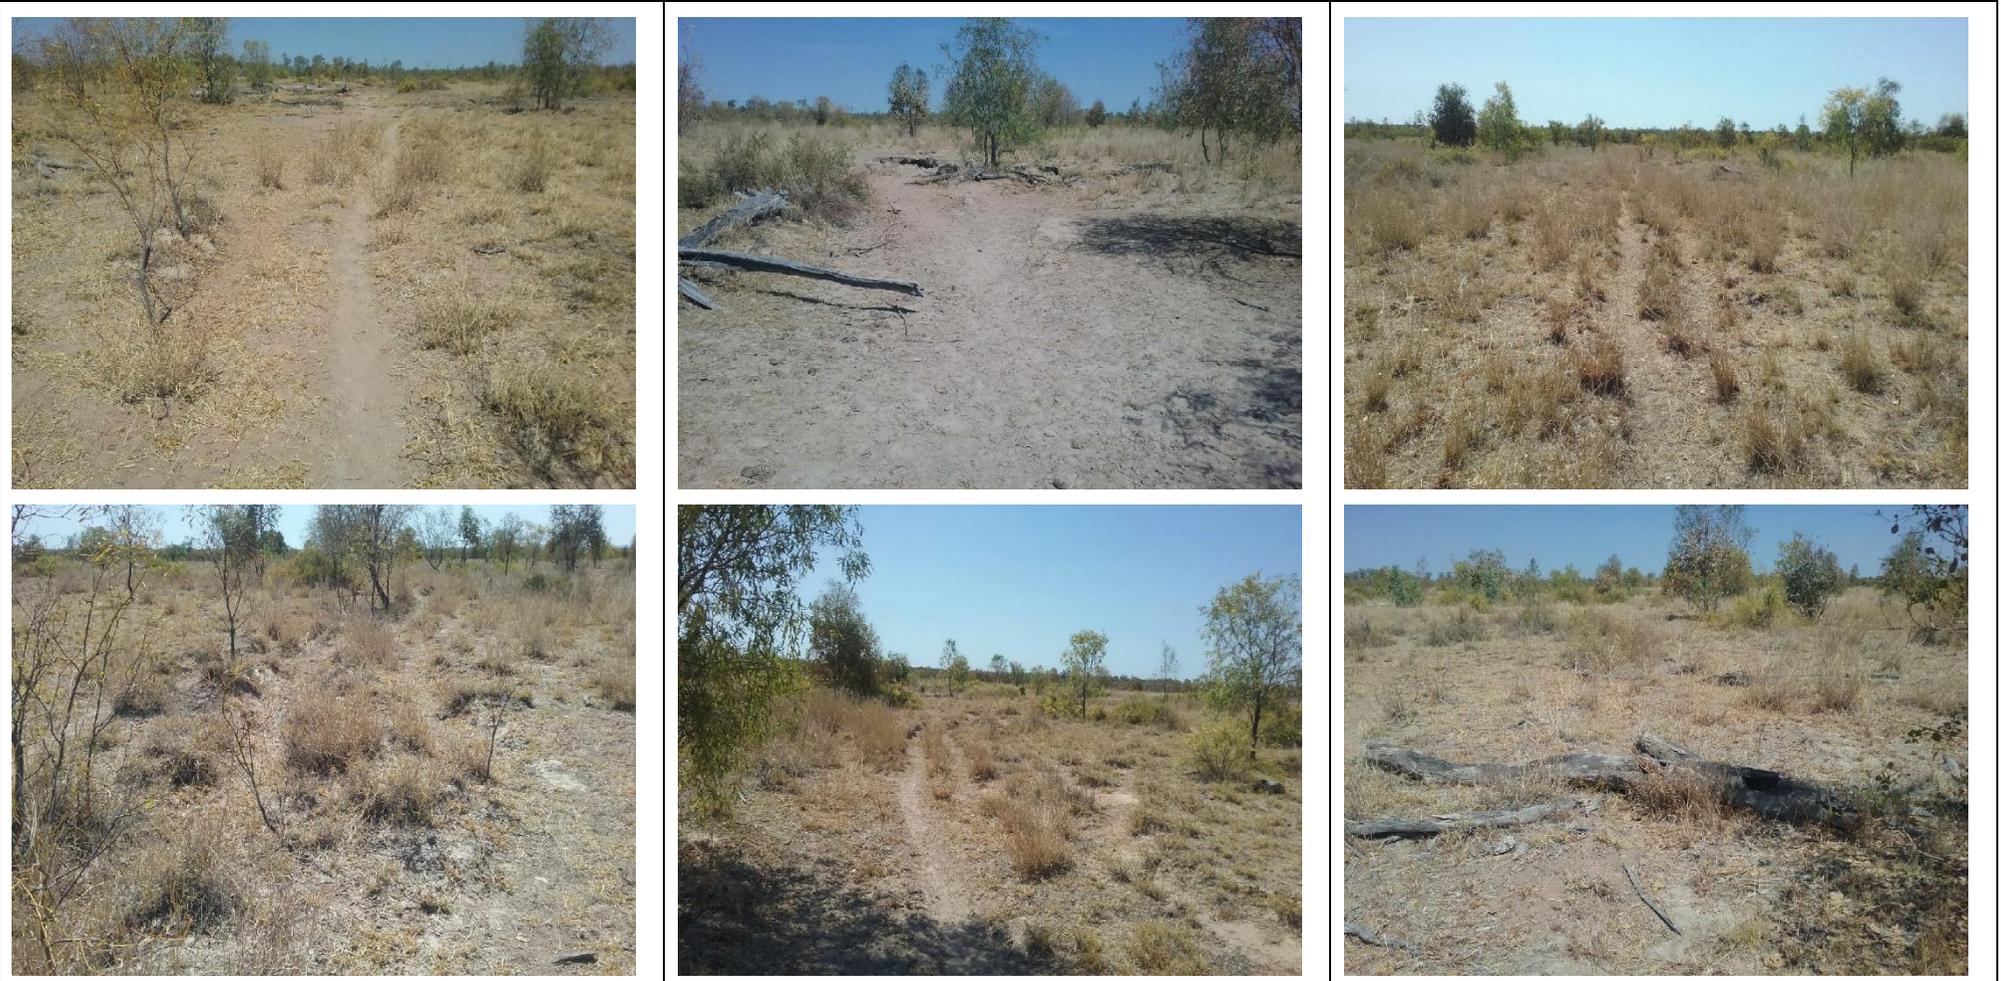
Location 32 - Gully becomes shallow drain (2 photos)

Location 33 (2 photos)

Location 34 - Drain peters out (2 photos)
