71 Ash Street (PO BOX 191)
Barcaldine QLD 4725

DRINKING WATER QUALITY MANAGEMENT PLAN

May 2018

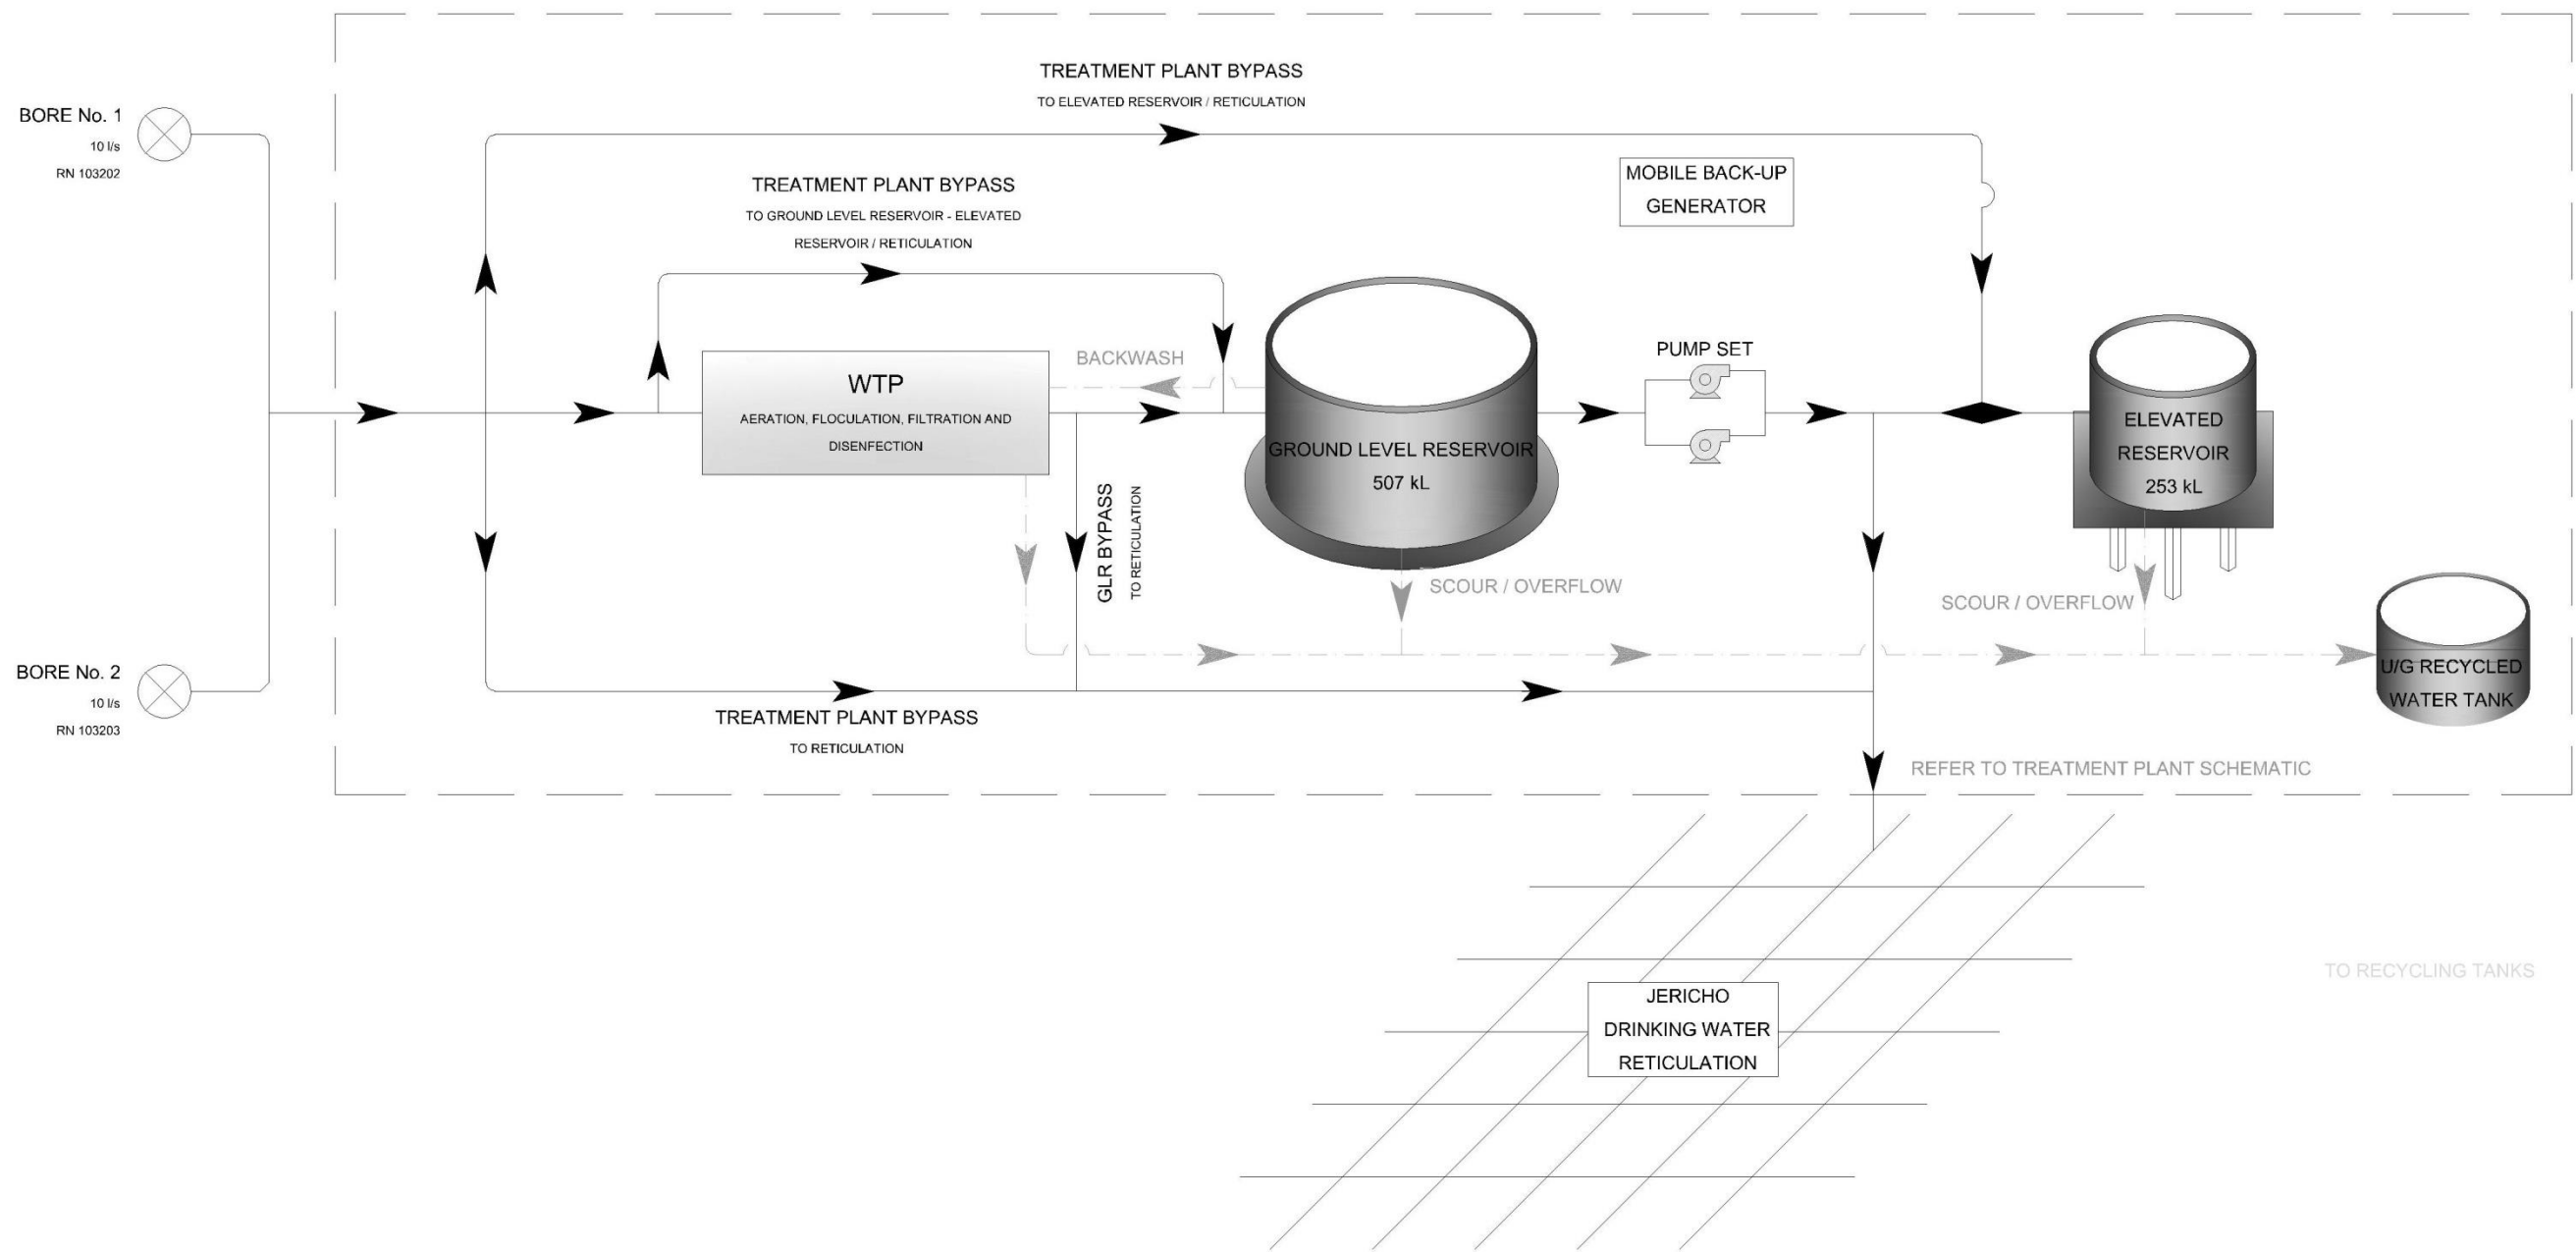
Figure 2.5 Jericho Service Schematic Layout

Figure 2.5 shows a schematic of the Jericho water supply scheme. Figure 2.6 shows a schematic of the Jericho Water Treatment Plant. Refer to Appendix B for water supply layouts superimposed on aerial photos.
